PRODUCT PERFORMANCE TEST REPORT

Report No.: D7226.01-121-24

PRODUCT TYPE: Tubular Daylight Device (TDD)
SERIES/MODEL: 21 inch Natural Light Tubular Skylight

SPECIFICATION: ASTM E 108-11, *Standard Test Methods for Fire Tests of Roof Coverings (Burning Brand Only)*

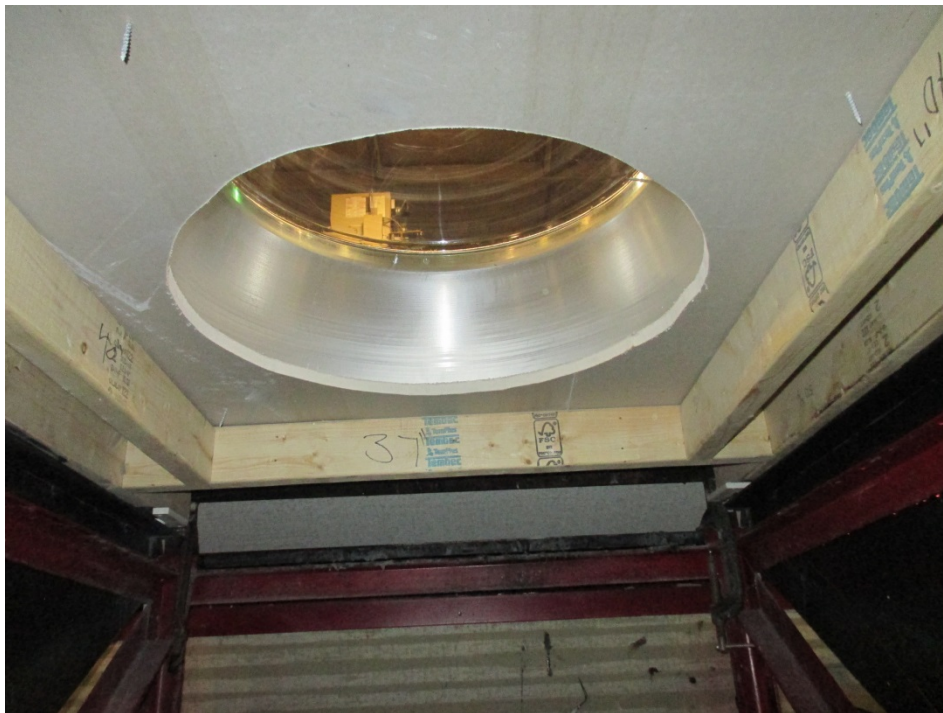
Photo No. 2
Underside of Specimen & Test Deck (Pre-test)

4.1 Specimen Description: Class B test deck for the *Burning Brand* tests were constructed of 2x4 lumber and 5/8 inch Type X gypsum board. The TDD was attached to the test deck with 1-1/2 inch drywall screws. A ring was cut out of the test deck so observations could be made on the progress of the flame penetration from the burning brands.

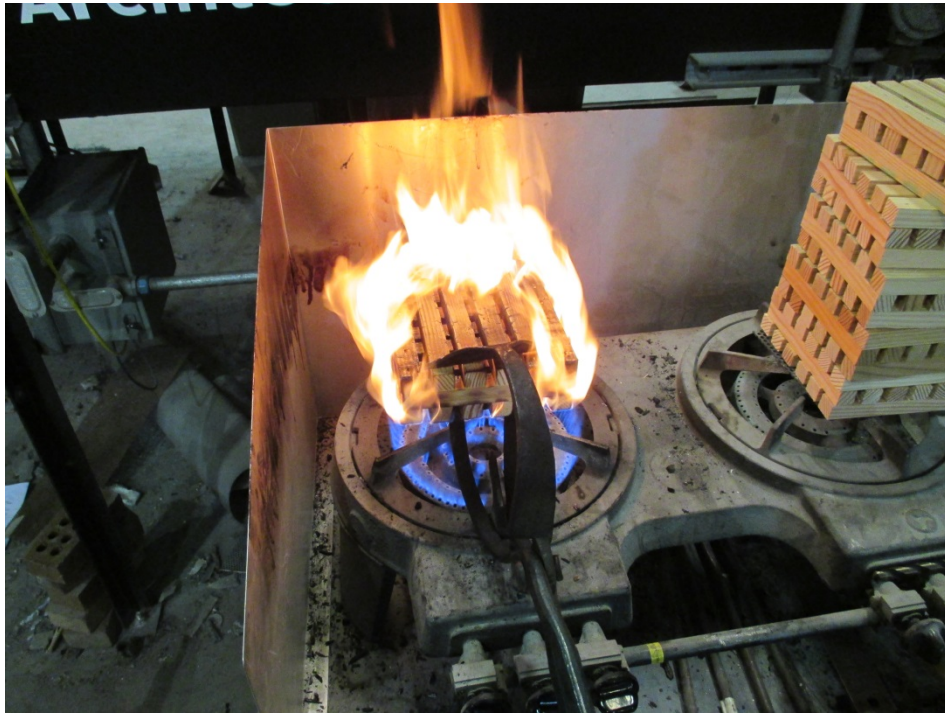
Photo No. 3
Ignition of Brands

4.4 Equipment Calibration: A Fire Test Apparatus as described in ASTM E 108 was used to generate 12 ± 0.5 mph air current. Air speed of the Fire Test Apparatus was calibrated prior to testing. A gas burner with flame temperature of $1630 \pm 50^\circ\text{F}$ was used to ignite the brands for testing. See Section 5.1 for more information on equipment calibration.

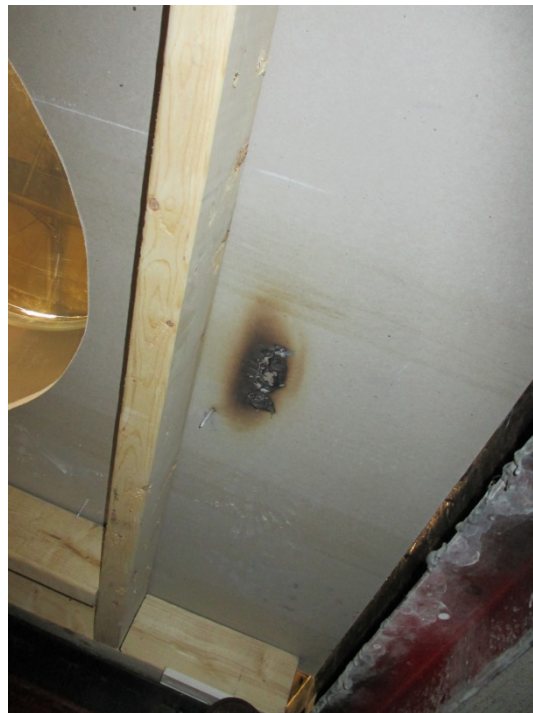
Photo No. 6
Underside of Gypsum Board (During Test)

Time (min:sec)	Event	Observations
00:01	Brand placed on deck	Start of test, 1 st Class B Brand placed
05:49	Smoking	Smoke leaking between gypsum board and flashing
15:30	Brand consumed	1 st Class B Brand consumed
15:30	Brand placed on deck	2 nd Class B Brand placed
32:00	Brand consumed	2 nd Class B Brand consumed
32:00	Brand placed on deck	3 rd Class B Brand placed
47:43	Brand consumed	3 rd Class B Brand consumed
47:43	Brand placed on deck	4 th Class B Brand placed
49:26	Substrate Fatigue	Gypsum board is starting to show signs of burn through.
1:02:26	Brand consumed	4 th Class B Brand consumed
1:02:26	Brand placed on deck	5 th Class B Brand placed
1:16:00	Brand consumed	5 th Class B Brand consumed

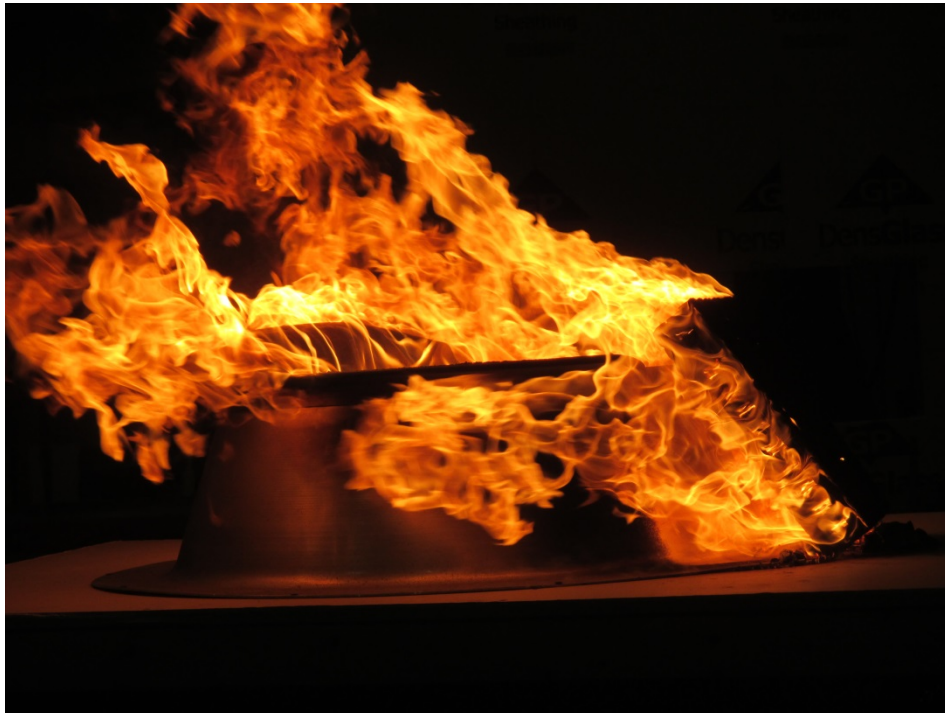
Photo No. 7
Class A Brand (During Test)

4.5 Burning Brand Procedure: After calibration of equipment, a test specimen described in Section 4.1 was placed into the steel framed holder for testing at a 0:12 slope. Brands were oven conditioned at 105 to 120°F for a minimum of 24 hours prior to testing and weight verified to be within 500 ± 50 grams. Each Class B brand consisted of three layers of six 1 inch by 1 inch by 6 inch strips of Douglas Fir forming a grid of 6 inch square by 2-1/4 inch thick. The brand was ignited by exposing each 6 inch by 6 inch face for 30 seconds, each 2-1/4 inch by 6 inch face for 30 seconds, and the and the 6 inch by 6 inch faces again for 30 seconds into the gas burner. Total duration of ignition exposure was 4 minutes. After the brand was ignited, it was placed onto the test specimen and secured in place with No. 18 soft iron wire. Location of each brand was on the edge of the TDD ring facing the side the skylight adjacent to the wind currents. Fire Test Apparatus without flame but only air current was turned on and the specimen was tested until the brand ceased to exhibit burning characteristics. After the brand was extinguished, another brand was placed in the same location. This procedure was repeated for seven Class B brands and the TDD still did not allow flames to penetrate the ring or through the translucent dome. Specimen only failed when a Class A brand was placed against the ring.

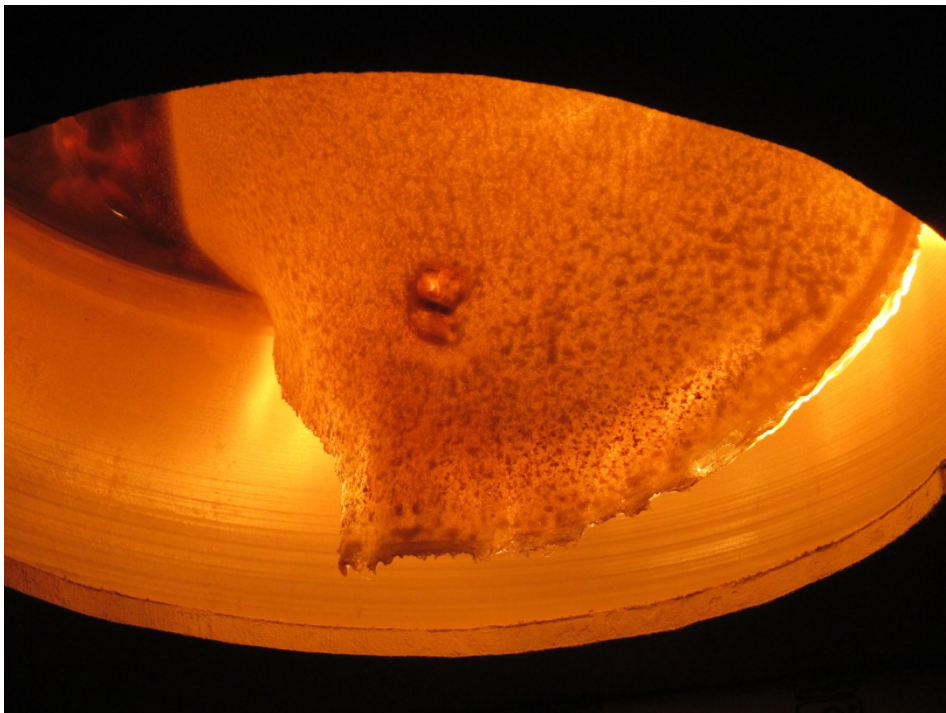
Photo No. 8
Melting of Dome after Class A Brand Exposure (During Test)

Time (min:sec)	Event	Observations
1:16:00	Brand placed on deck	6 th Class B Brand placed
1:19:36	Dome Fatigue	Dome starting to discolor and melt
1:26:02	Brand consumed	6 th Class B Brand consumed
1:26:02	Brand placed on deck	7 th Class B Brand placed
1:38:20	Brand consumed	7 th Class B Brand consumed
1:38:20	Brand placed on deck	1 st Class A Brand placed
1:39:18	Dome Fatigue	Ignition and melting of dome.
1:40:21	Dome Fatigue	Dome dripping to floor. Drippings still flaming on floor
1:42:44	Ring Fatigue	Ring melting through
1:45:00	End of test	
After Test	PASS , when subjected to Class B brands.

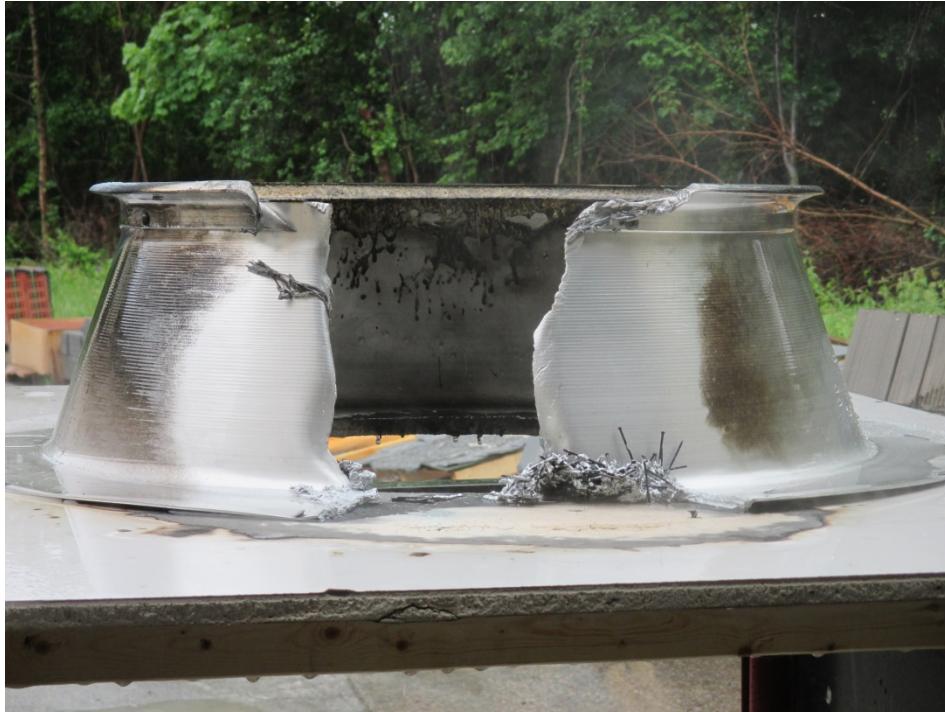
Photo No. 9
Specimen Post Seven Class B & One Class A Brand Exposure

Burning Brand	Classification	Result
BB #1	Class B	Pass
BB #2	Class B	Pass
BB #3	Class B	Pass
BB #4	Class B	Pass
BB #5	Class B	Pass
BB #6	Class B	Pass
BB #7	Class B	Pass
BB #8	Class A	Fail
